Project Construction Report – Photo Log

Pre-Deconstruction Site Walks

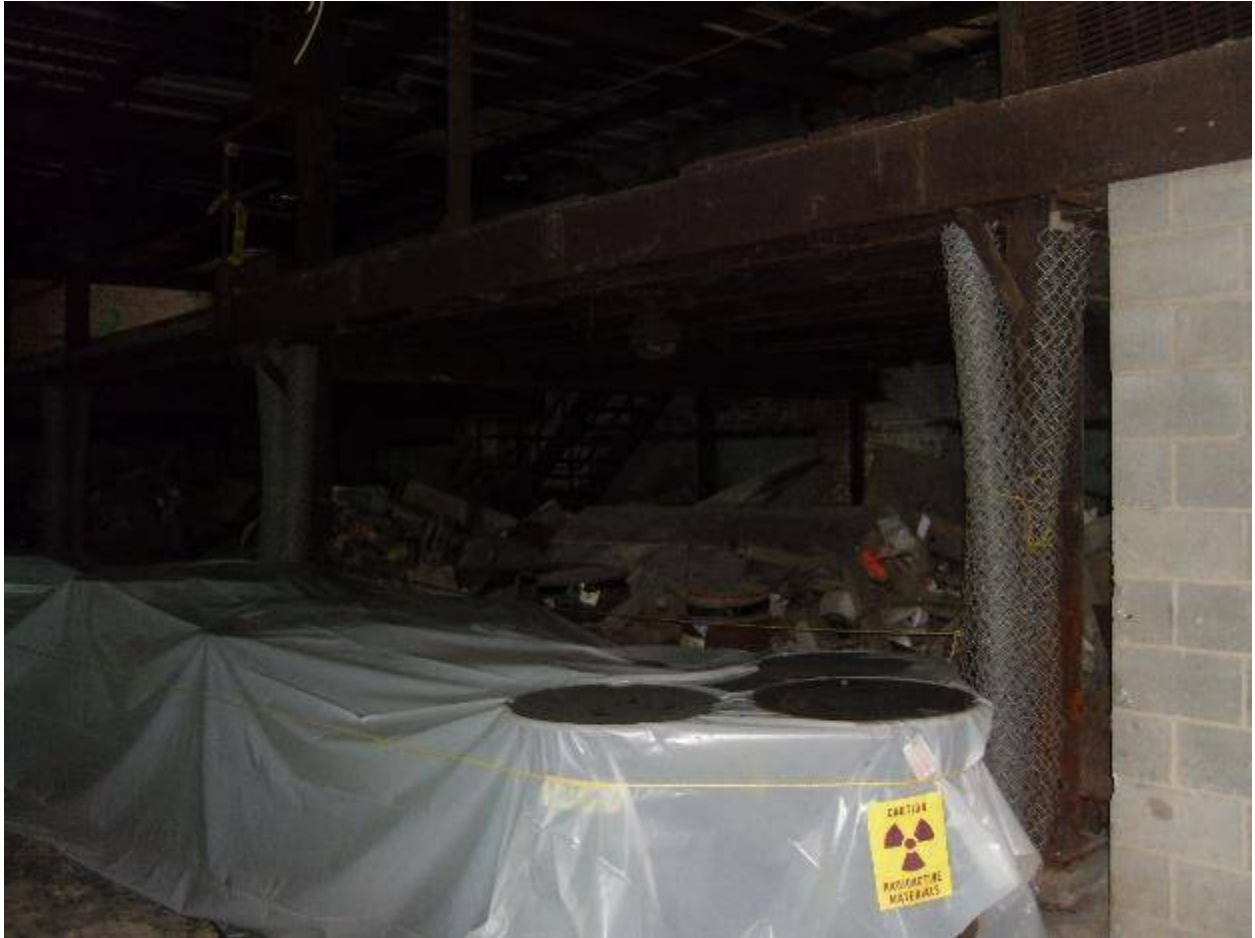
09/03/2014: View of the interior debris and wastes located within Building G-1

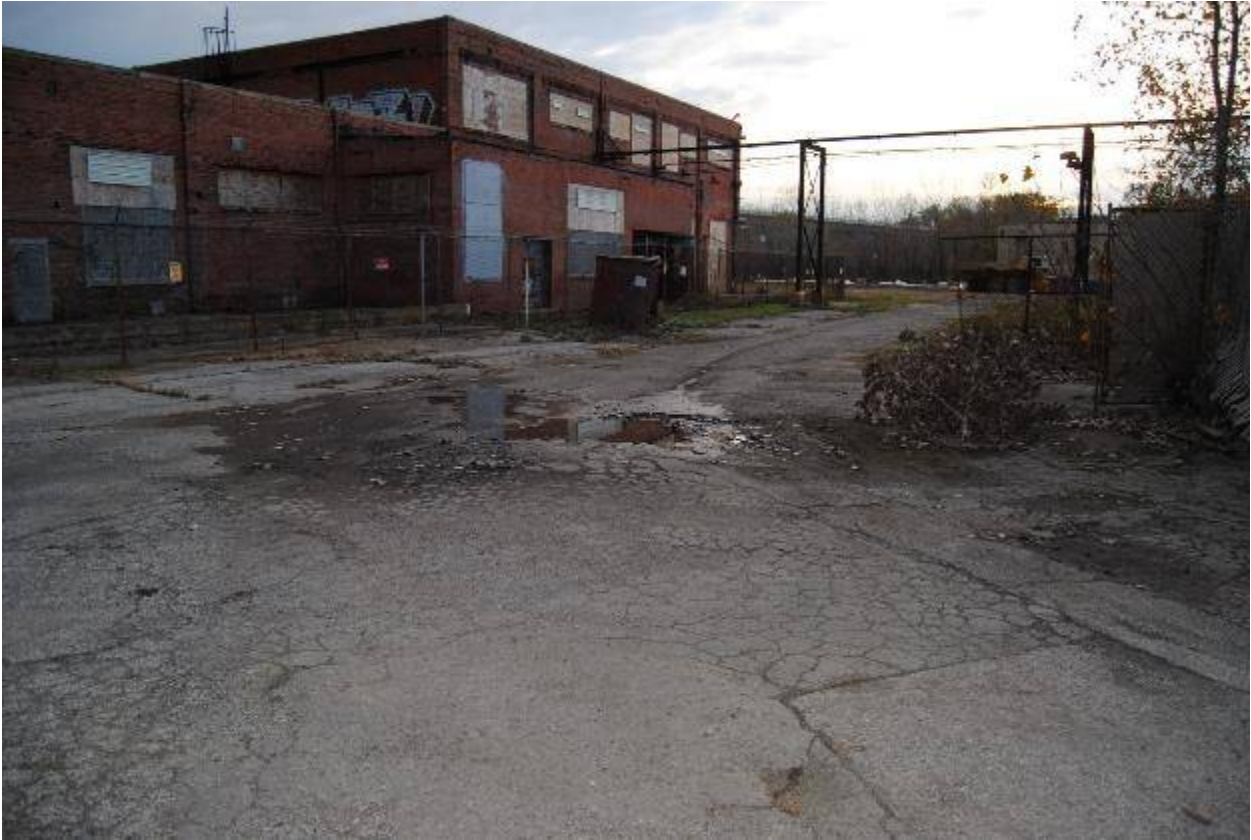
September 2014: View of the southern side of Building G-1. Note the overhead steam-pipe.

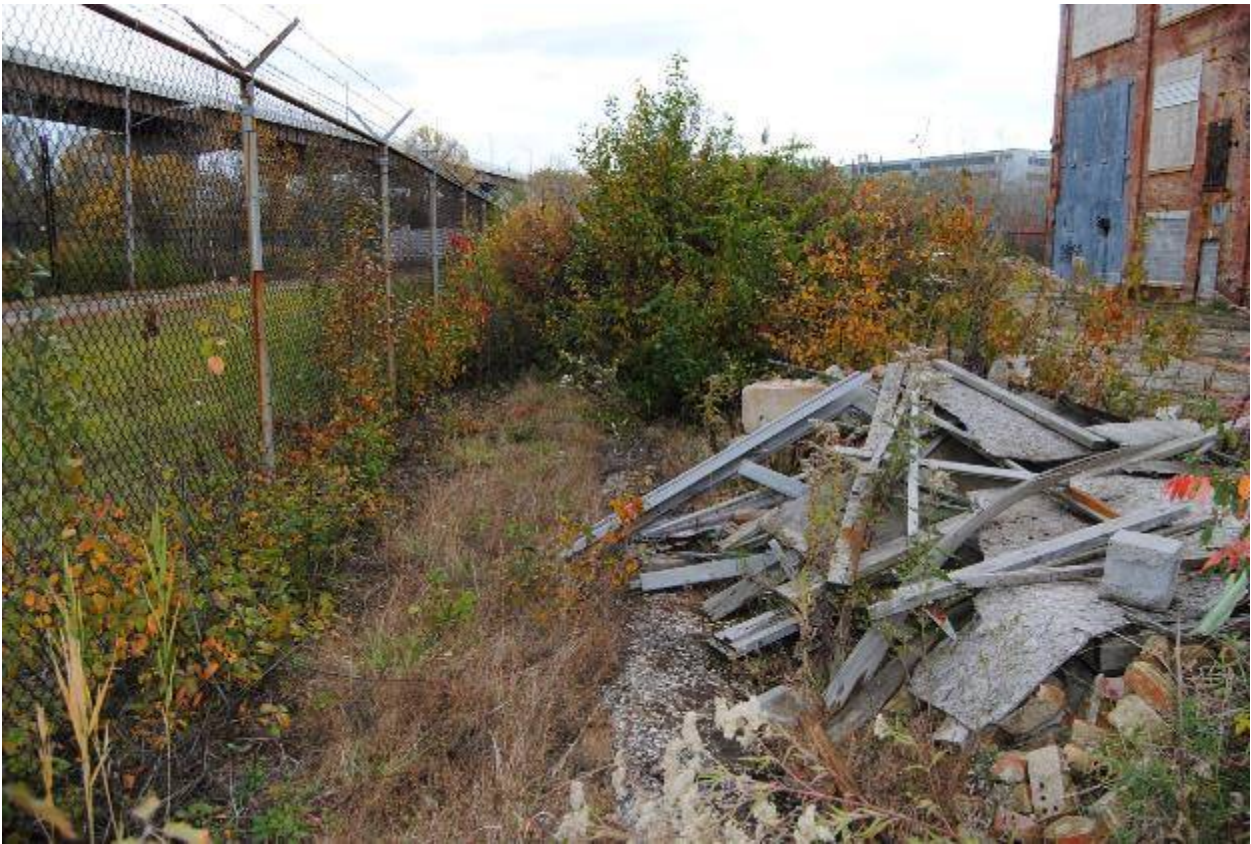
10/19/2014: View of the miscellaneous debris piles along the northern fence-line of Building G-1.

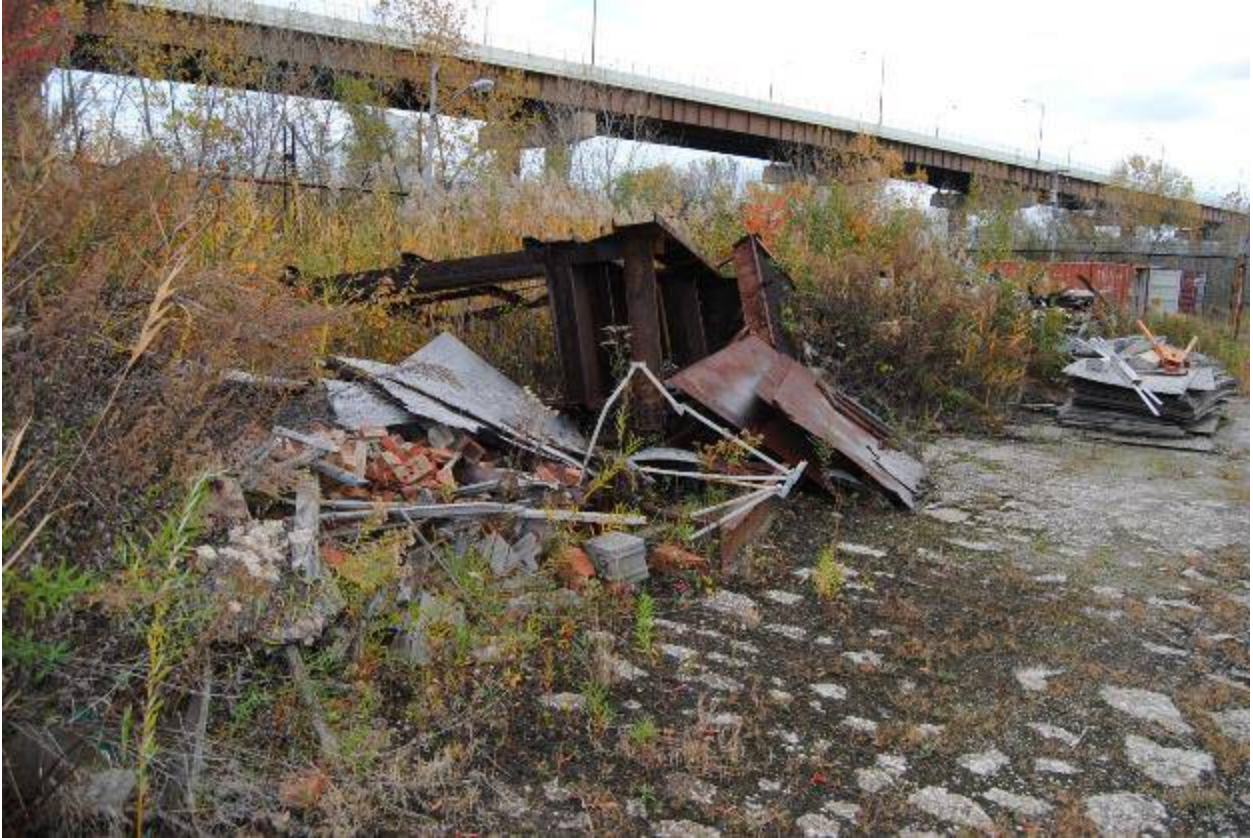
10/19/2014: Additional view of the miscellaneous debris piles along the norther fence-line of Building G-1.

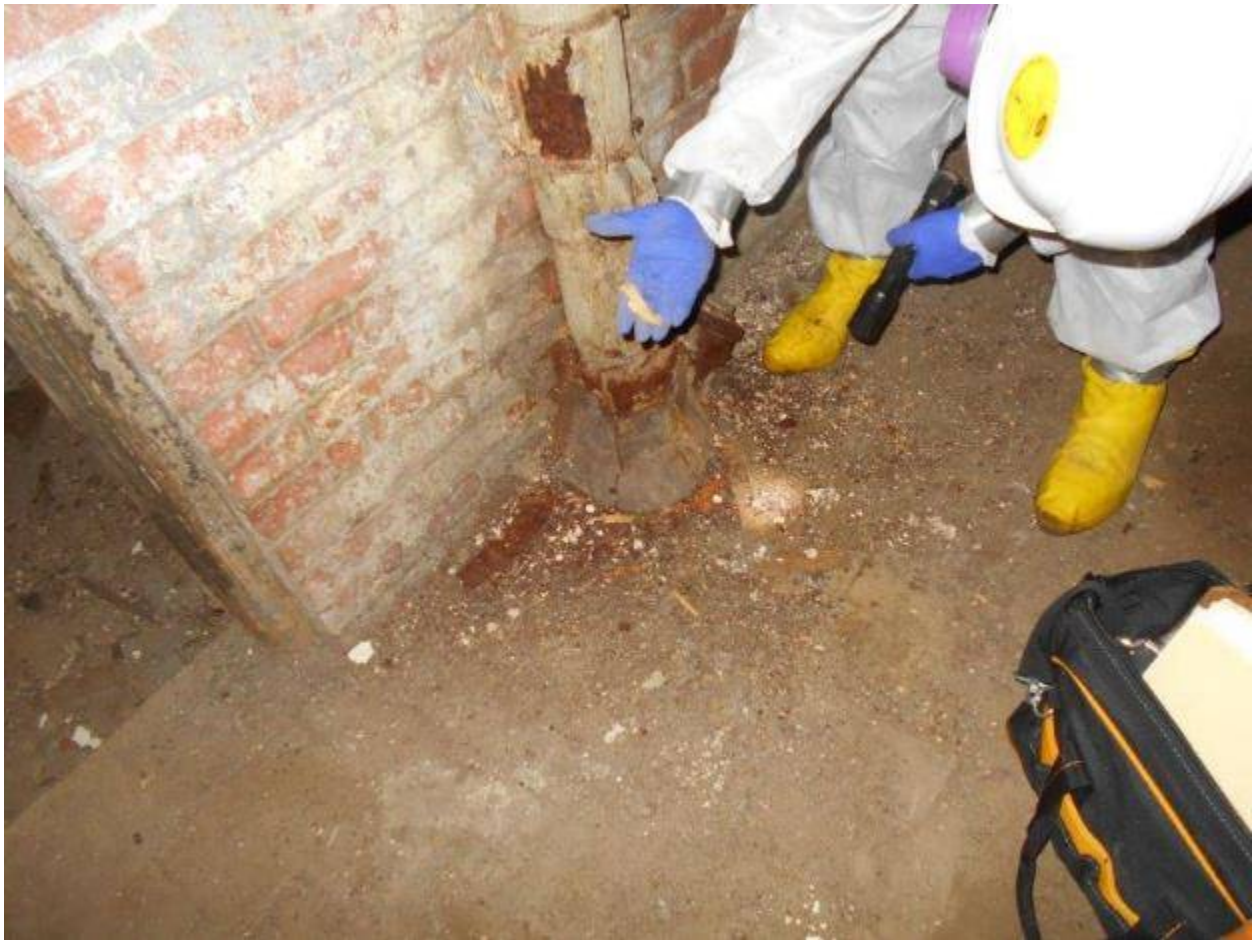
11/16/2014: View of insulation on interior piping.

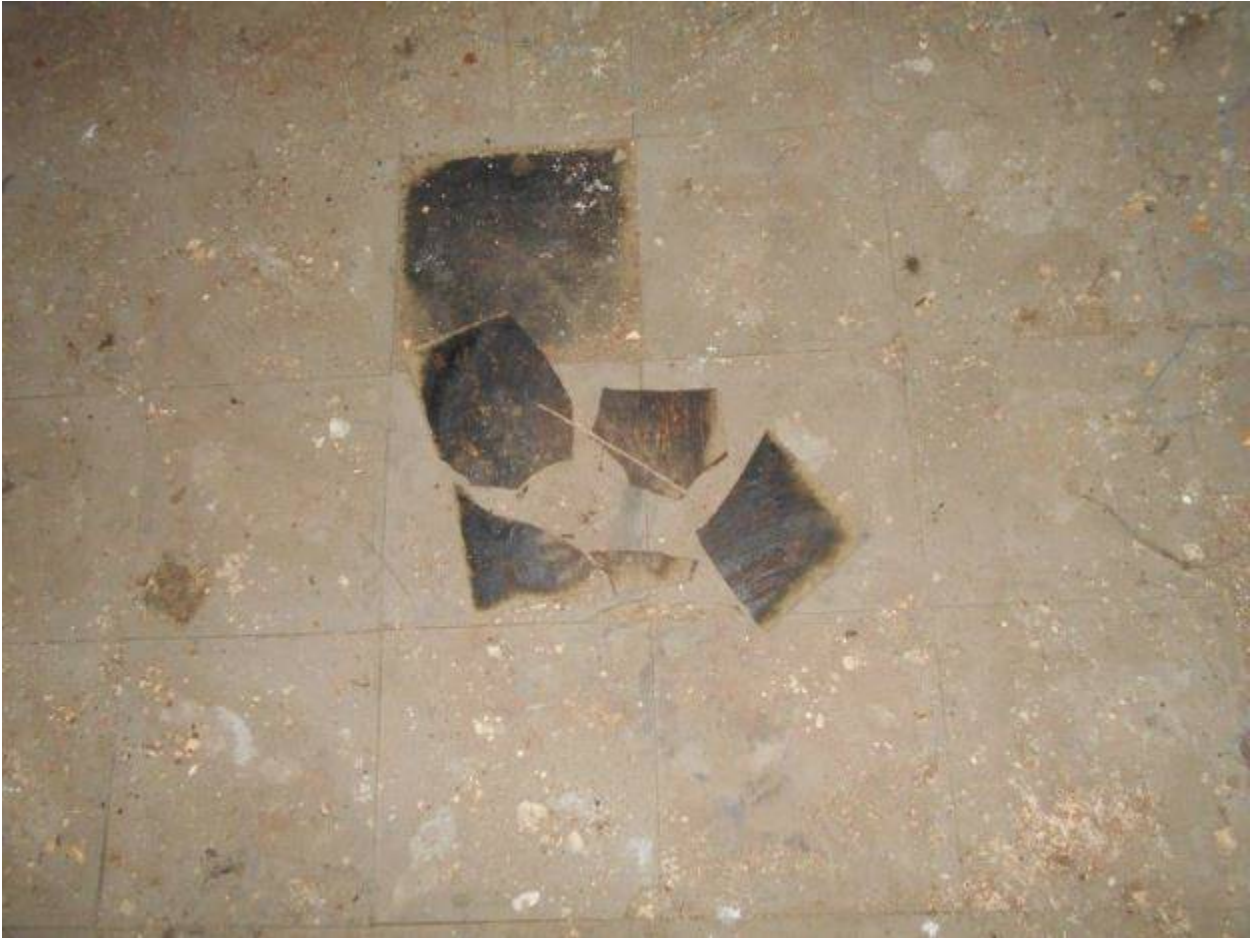
11/16/2014: View of floor tile and mastic.

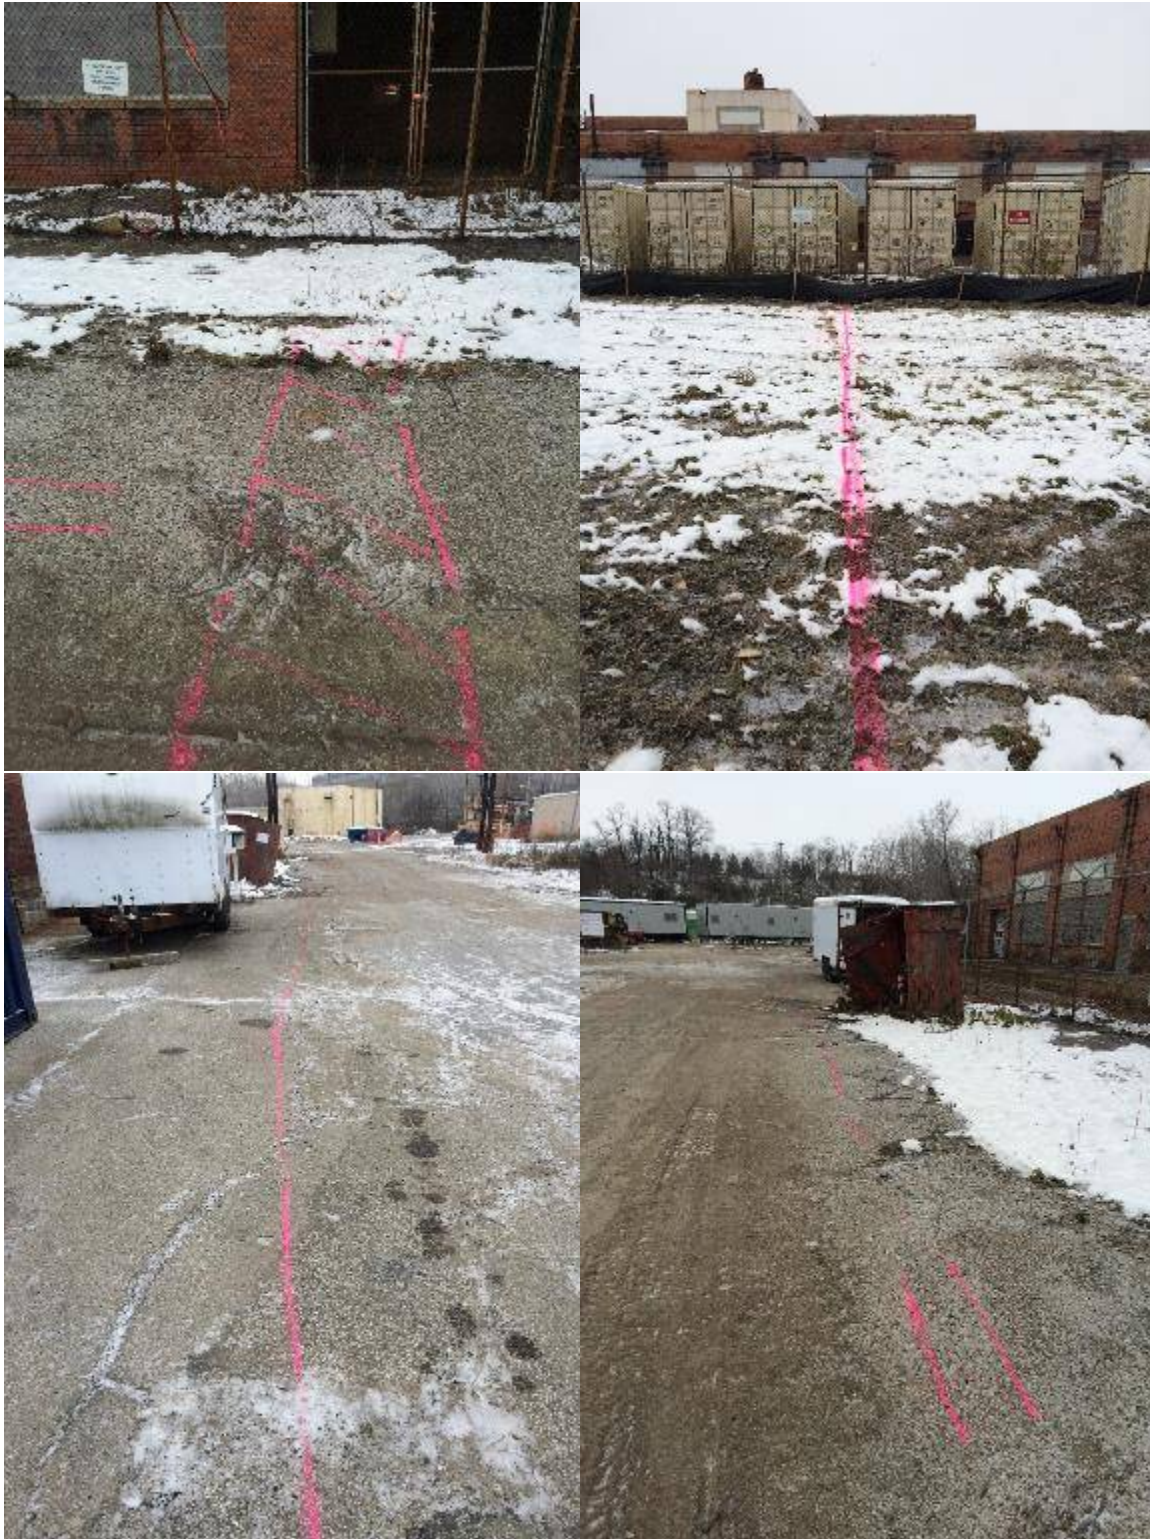
11/19/2014: Views of utility conduits, voids, and potentially ferrous anomalies marked out by the geophysics team.

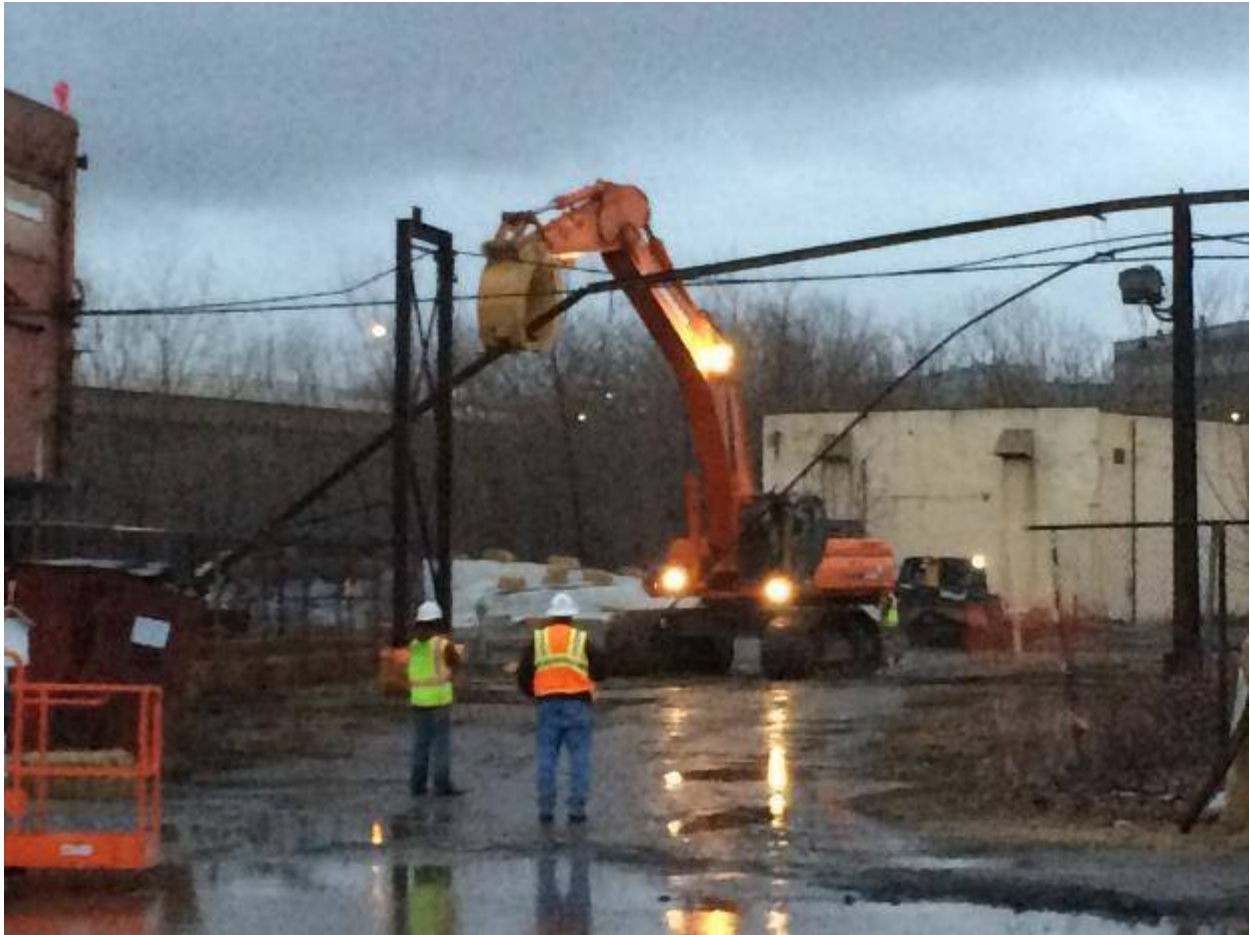
12/16/2014: Removal of the overhead steam pipe from the southern end of Building G-1 prior to the demolition of the steel and brick structure.

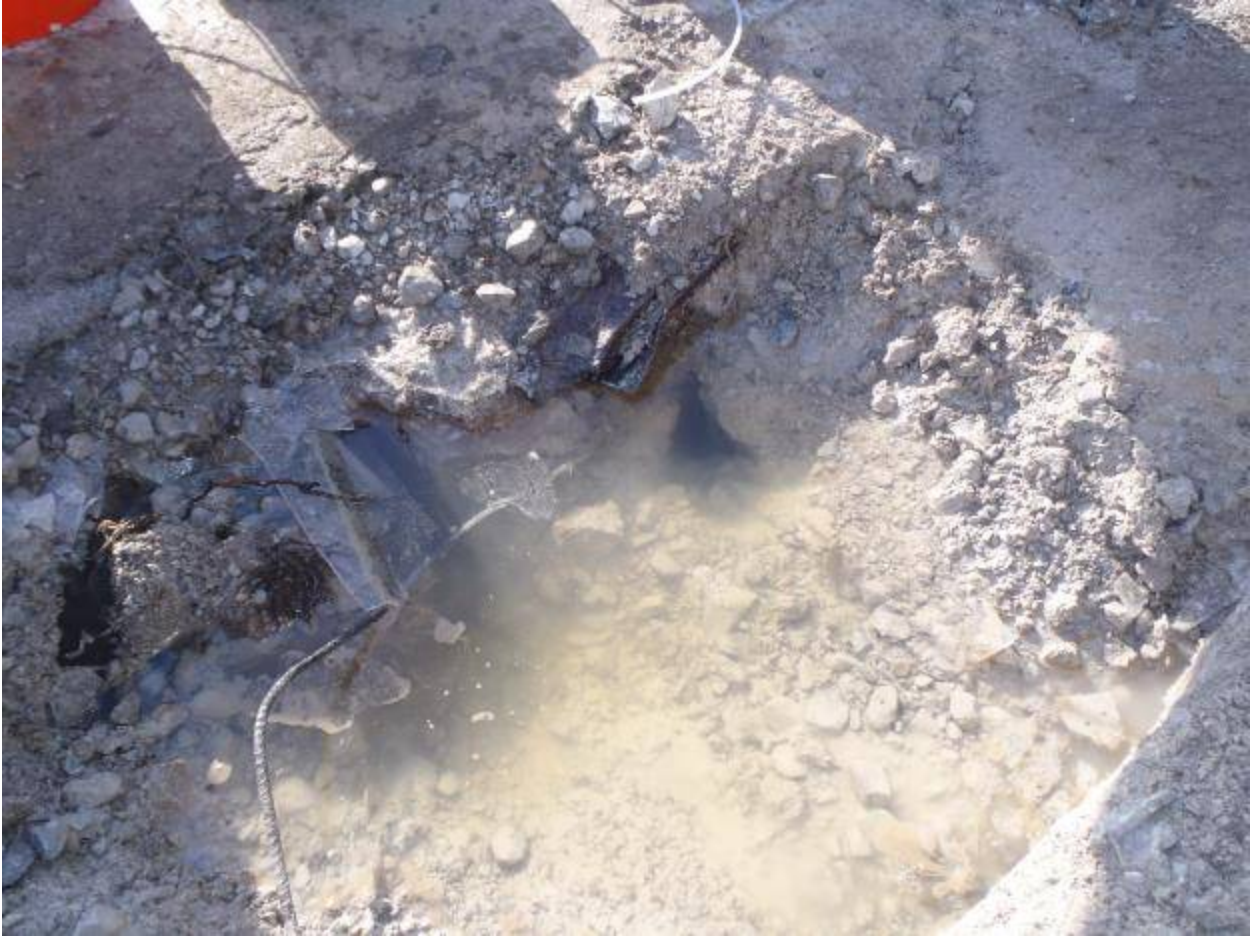
01/28/2015: view of the water incoming and continuously filling Test Pit #4.

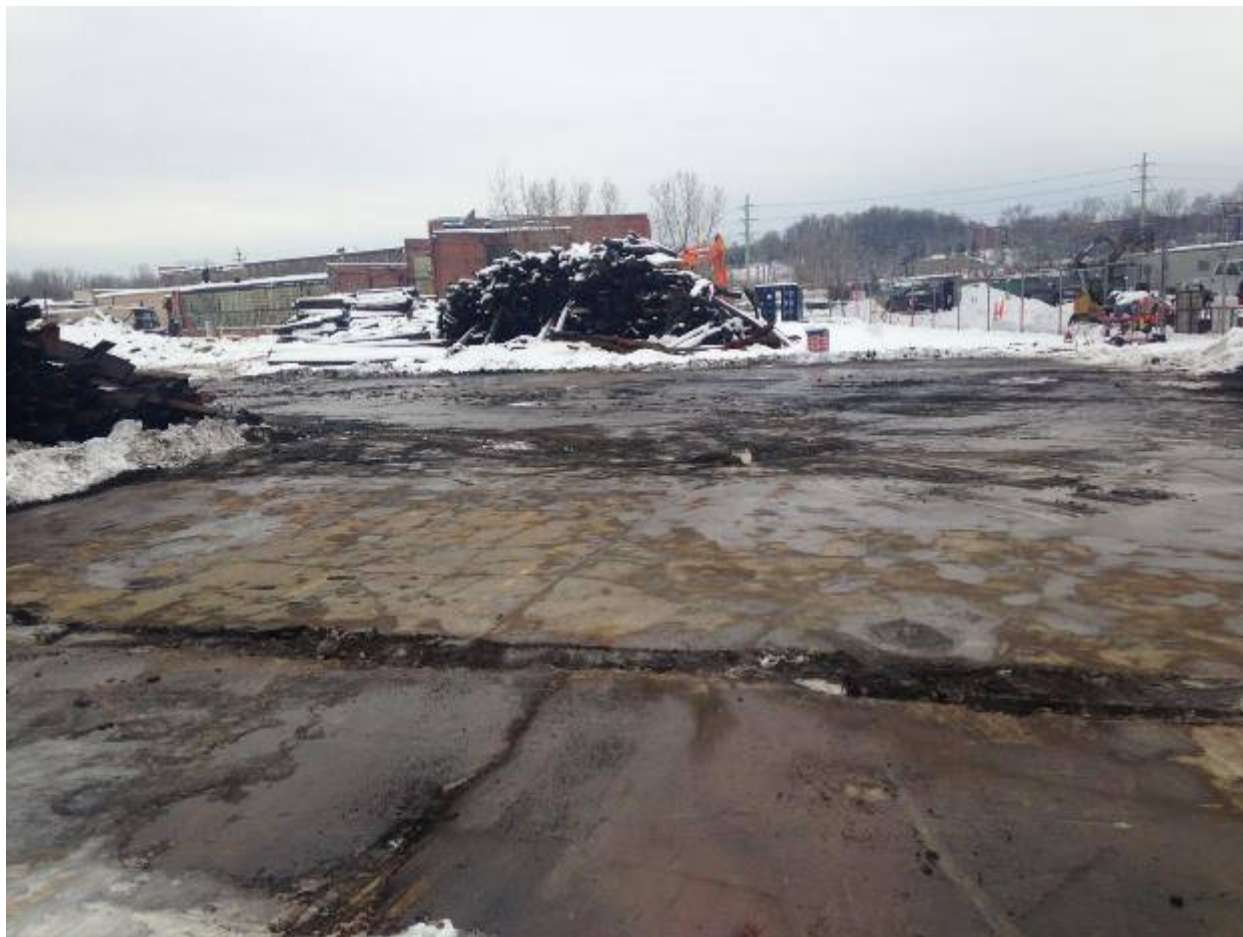
2/4/2015: As debris is cleared from the building pad, the area of the pad is cleaned, decontaminated, and surveyed with wipes to determine if it is suitable for clearance under the Nuclear Regulatory Commission (NRC) regulation 1.86. This is the Northwest portion of the building pad, which was cleared first.

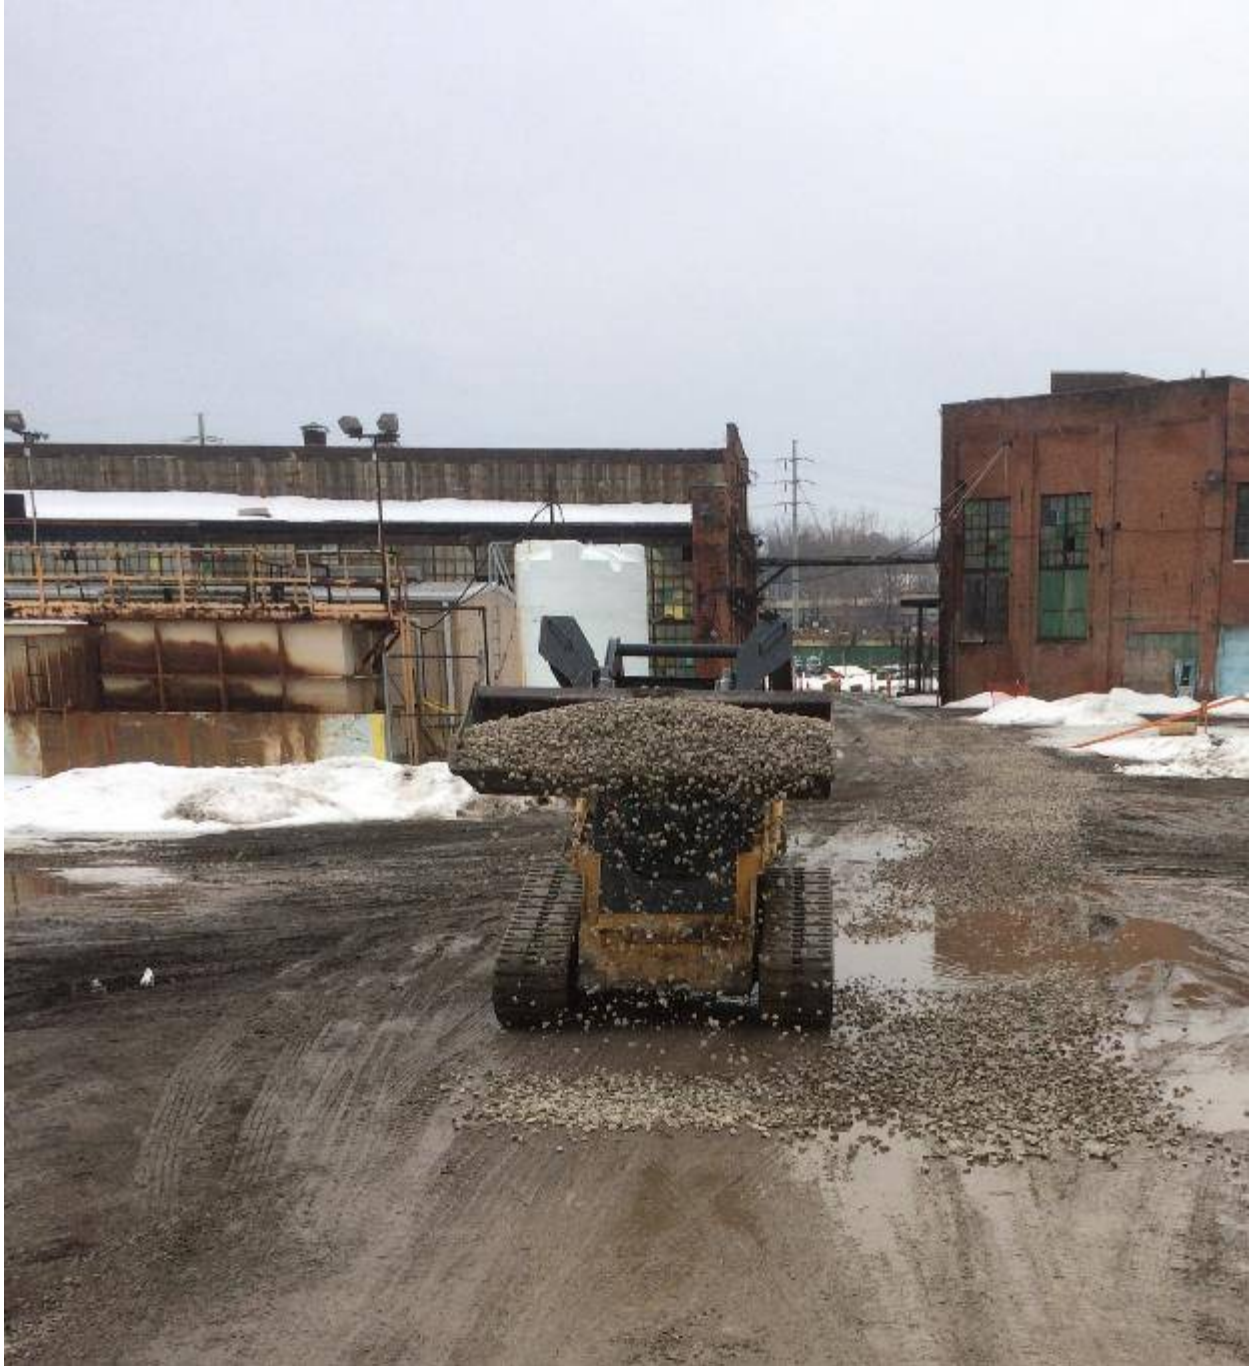
03/10/2015: haul route was reinforced with additional stone.

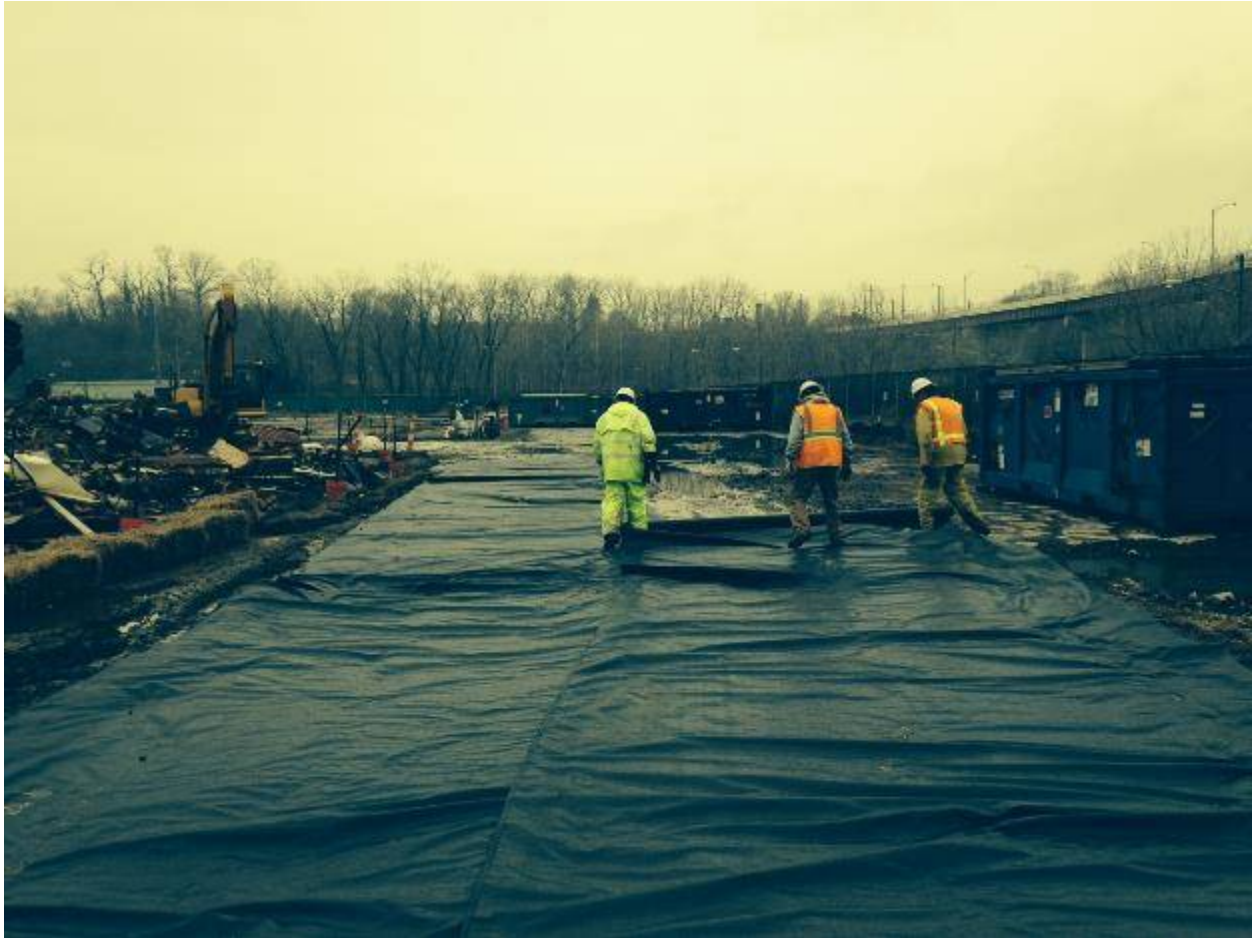
4/8/2015: to further stabilize the areas around Building G-1, geo-textile and stone were laid down in areas that were seen to be at risk for erosion from vehicle traffic. Pictured here is the area, just north of the Building G-1 slab (a.k.a. the former Building G-2 slab).
